MALIBU CREEK WATERSHED

# Ecosystem<sub>ON THE</sub> Brink

A SCIENTIFIC ROADMAP FOR PROTECTING A CRITICAL NATURAL RESOURCE

Heal the Bay

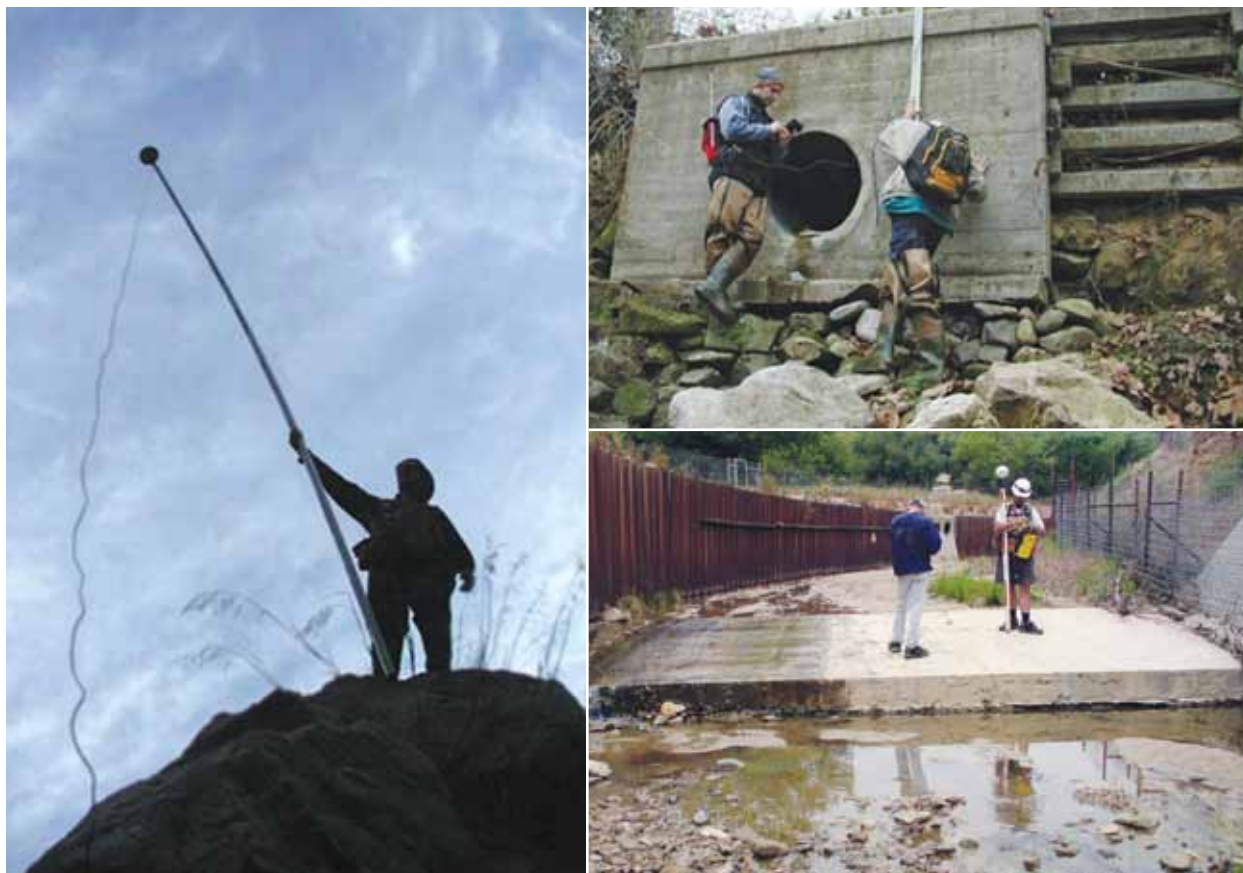
Mapping impairments in the watershed through the Stream Walk program (left), such as discharge points (right top) and streambank hardening (right bottom).

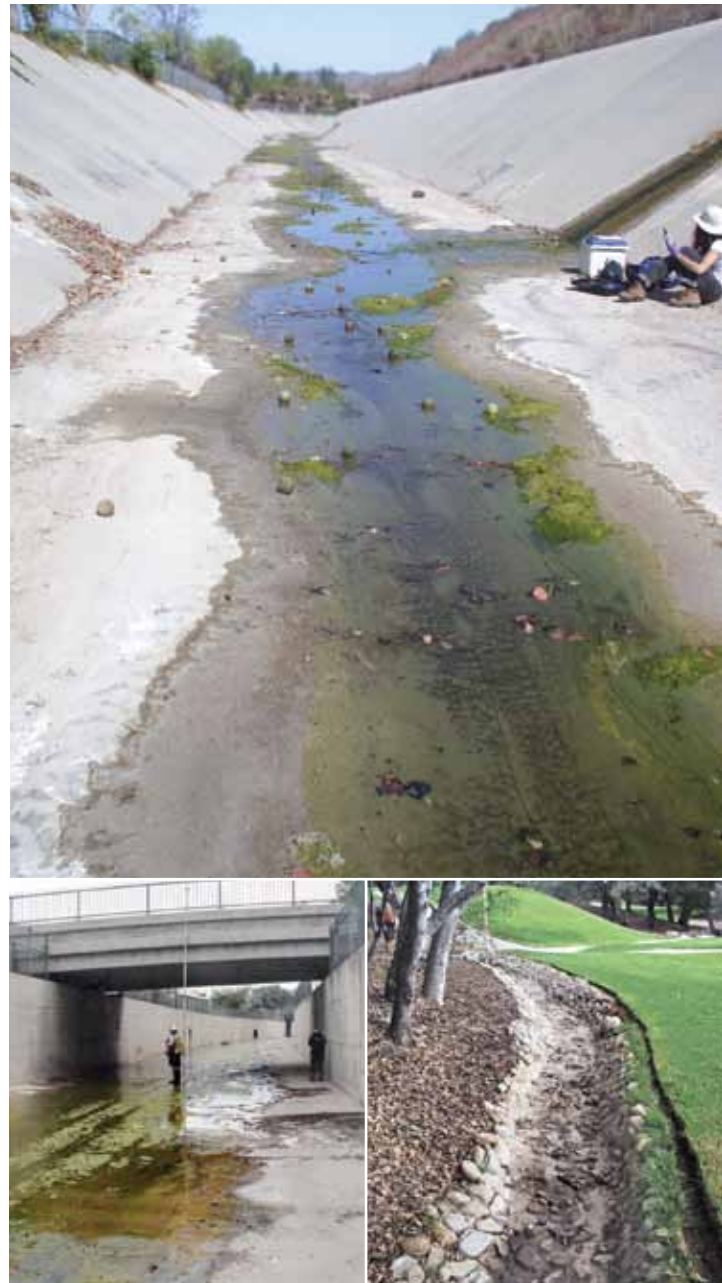
Clockwise from top: Channelized upper Las Virgenes Creek; Channelized Lindero Creek; Channelized Medea Creek. Bottom: Photo credit: Heal the Bay

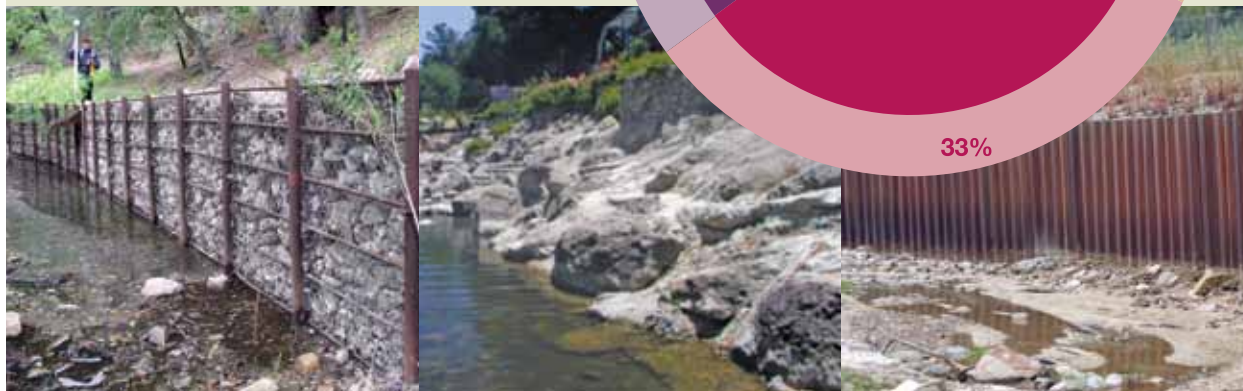
Photos (left to right): Fencing and gabion, concrete boulders, corrugated fencing.

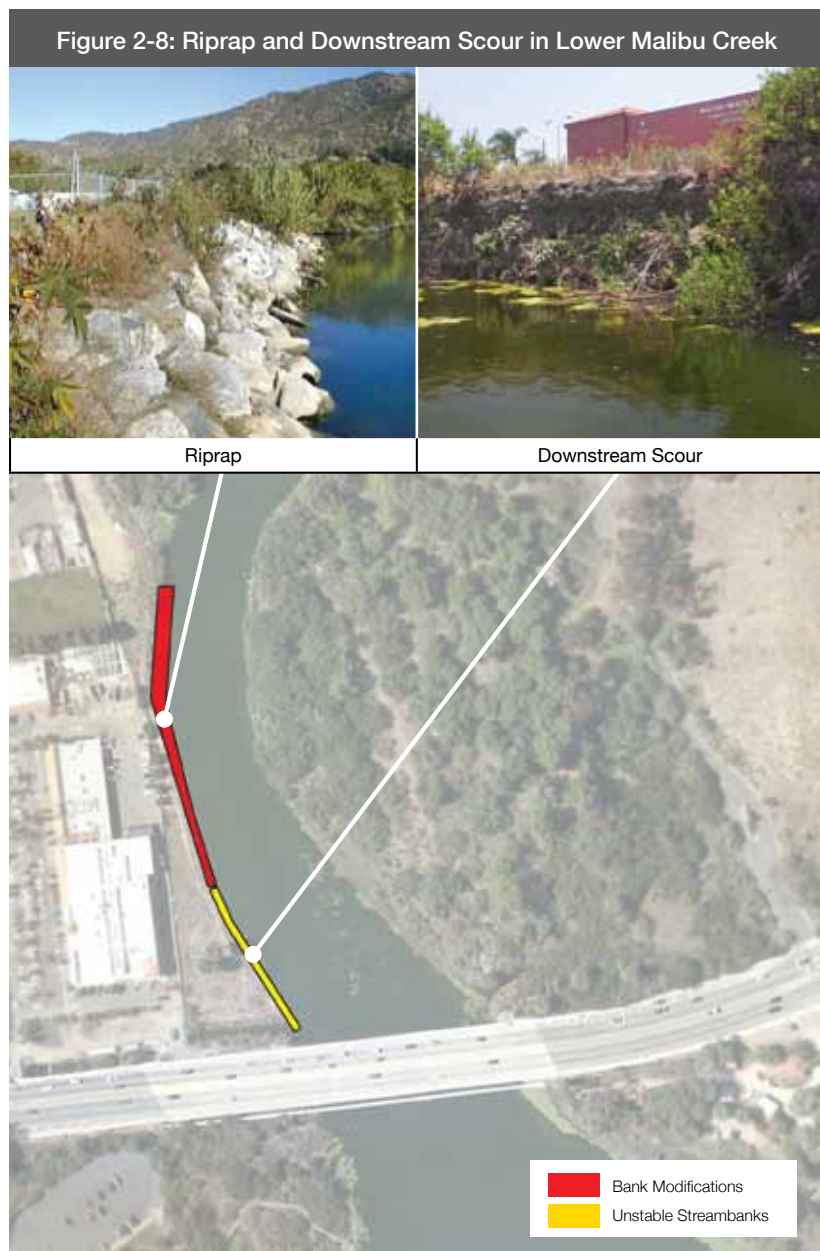
FIGURE 2-8: Digitized figure of riprap and downstream scour from 2000 to 2004 at the Mariposa property in lower Malibu Creek. Photos taken in 2011 to show similar conditions as previously mapped.

The riprap in lower Malibu Creek adjacent to the Malibu Creek Shopping Center provides an excellent, but unfortunately not unusual, example of the effects of streambank modification on riparian habitat. Following the 1998 El Nino and flooding events, the Coastal Commission approved a temporary streambank modification including large rocks, known as riprap, to stop the streambank from eroding further into private property. In early 2009, the revetment owners applied to permanently retain the approximately 500 linear feet of riprap. Despite inconsistencies with the City of Malibu's Local Coastal Program, the City and Coastal Commission approved a permit for permanent placement of the riprap in August 2012 with some efforts to add vegetation. However, as shown below, streambank scouring downstream from the riprap is causing erosion and will likely encroach on the commercial property and Malibu Lagoon State Park just below this area.

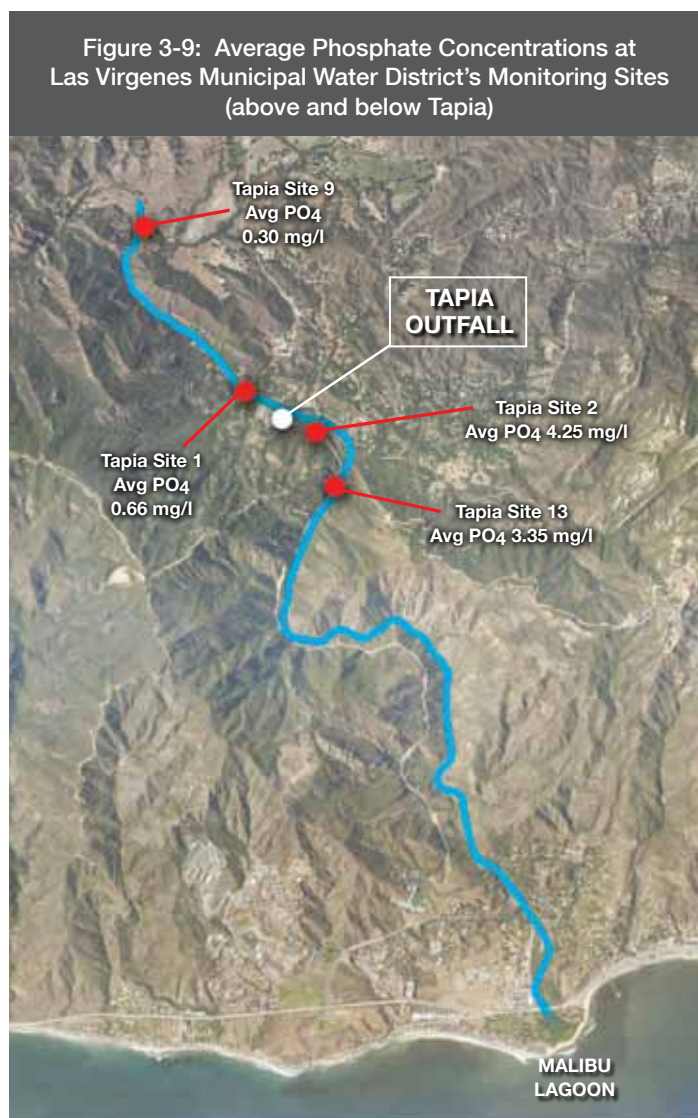
FIGURE 3-9: Average phosphate (mg/L) concentrations above and below the Tapia outfall between 2006 and 2009 during the permitted discharge period (November 16-April 14). Values were obtained from Tapia 2006-2009 NPDES annual reports and were reported monthly; we used data from December to March to calculate wet season averages. LVMWD monitoring locations are those shown in the Tapia 2009 NPDES Permit. The reported total phosphorus was converted to phosphate by multiplying by 3.<sup>45</sup>

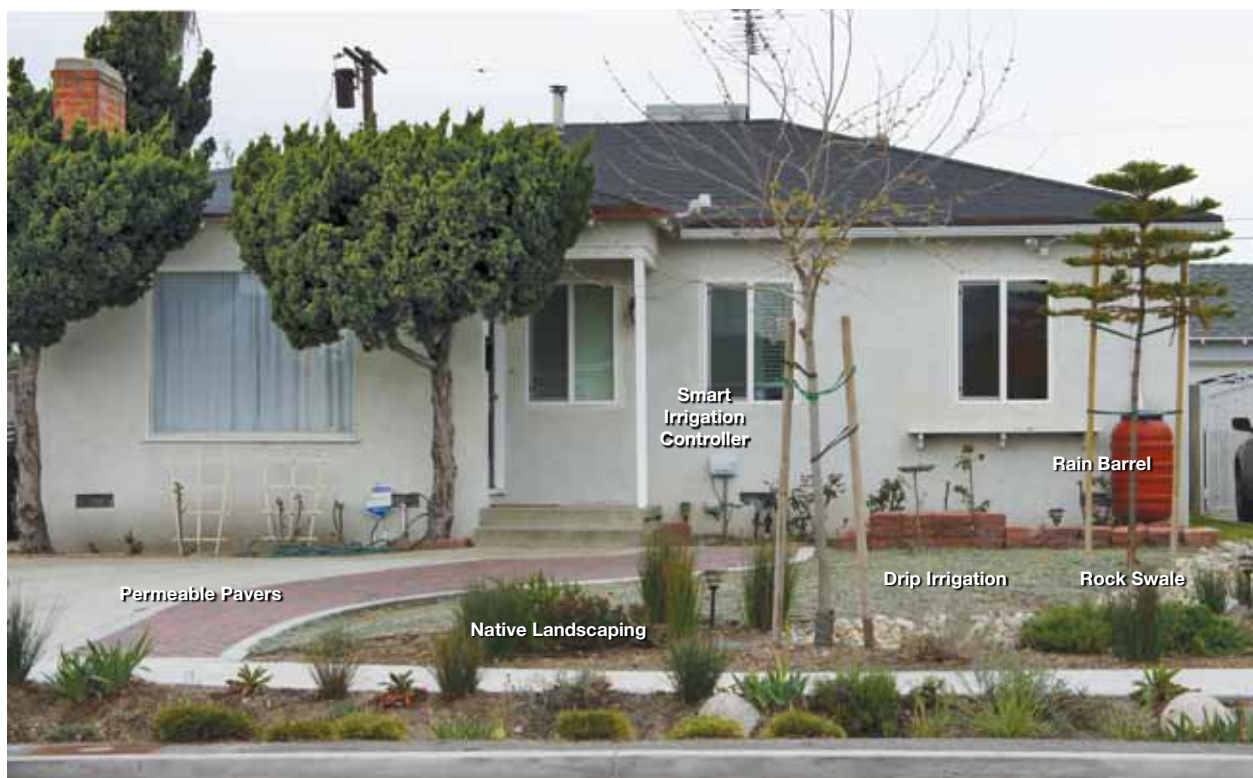
Local governments should adopt Low Impact Development (LID) ordinances that require onsite capture and reuse, or infiltration of 100% of the runoff generated from the 85th percentile storm. Pictured: Elmer Ave. Sun Valley LID demonstration house.
